Project: ARCS Regions VI, VII, and VIII, Contract No. 68-W9-0021

Subject: Butte Priority Soils Operable Unit (BPSOU)
November, 1994 Soil Sampling Results

BUTTE PRORITY SONS OPERABLE UNIT

NOVEMBER, 1994 SOIL SAMPLING

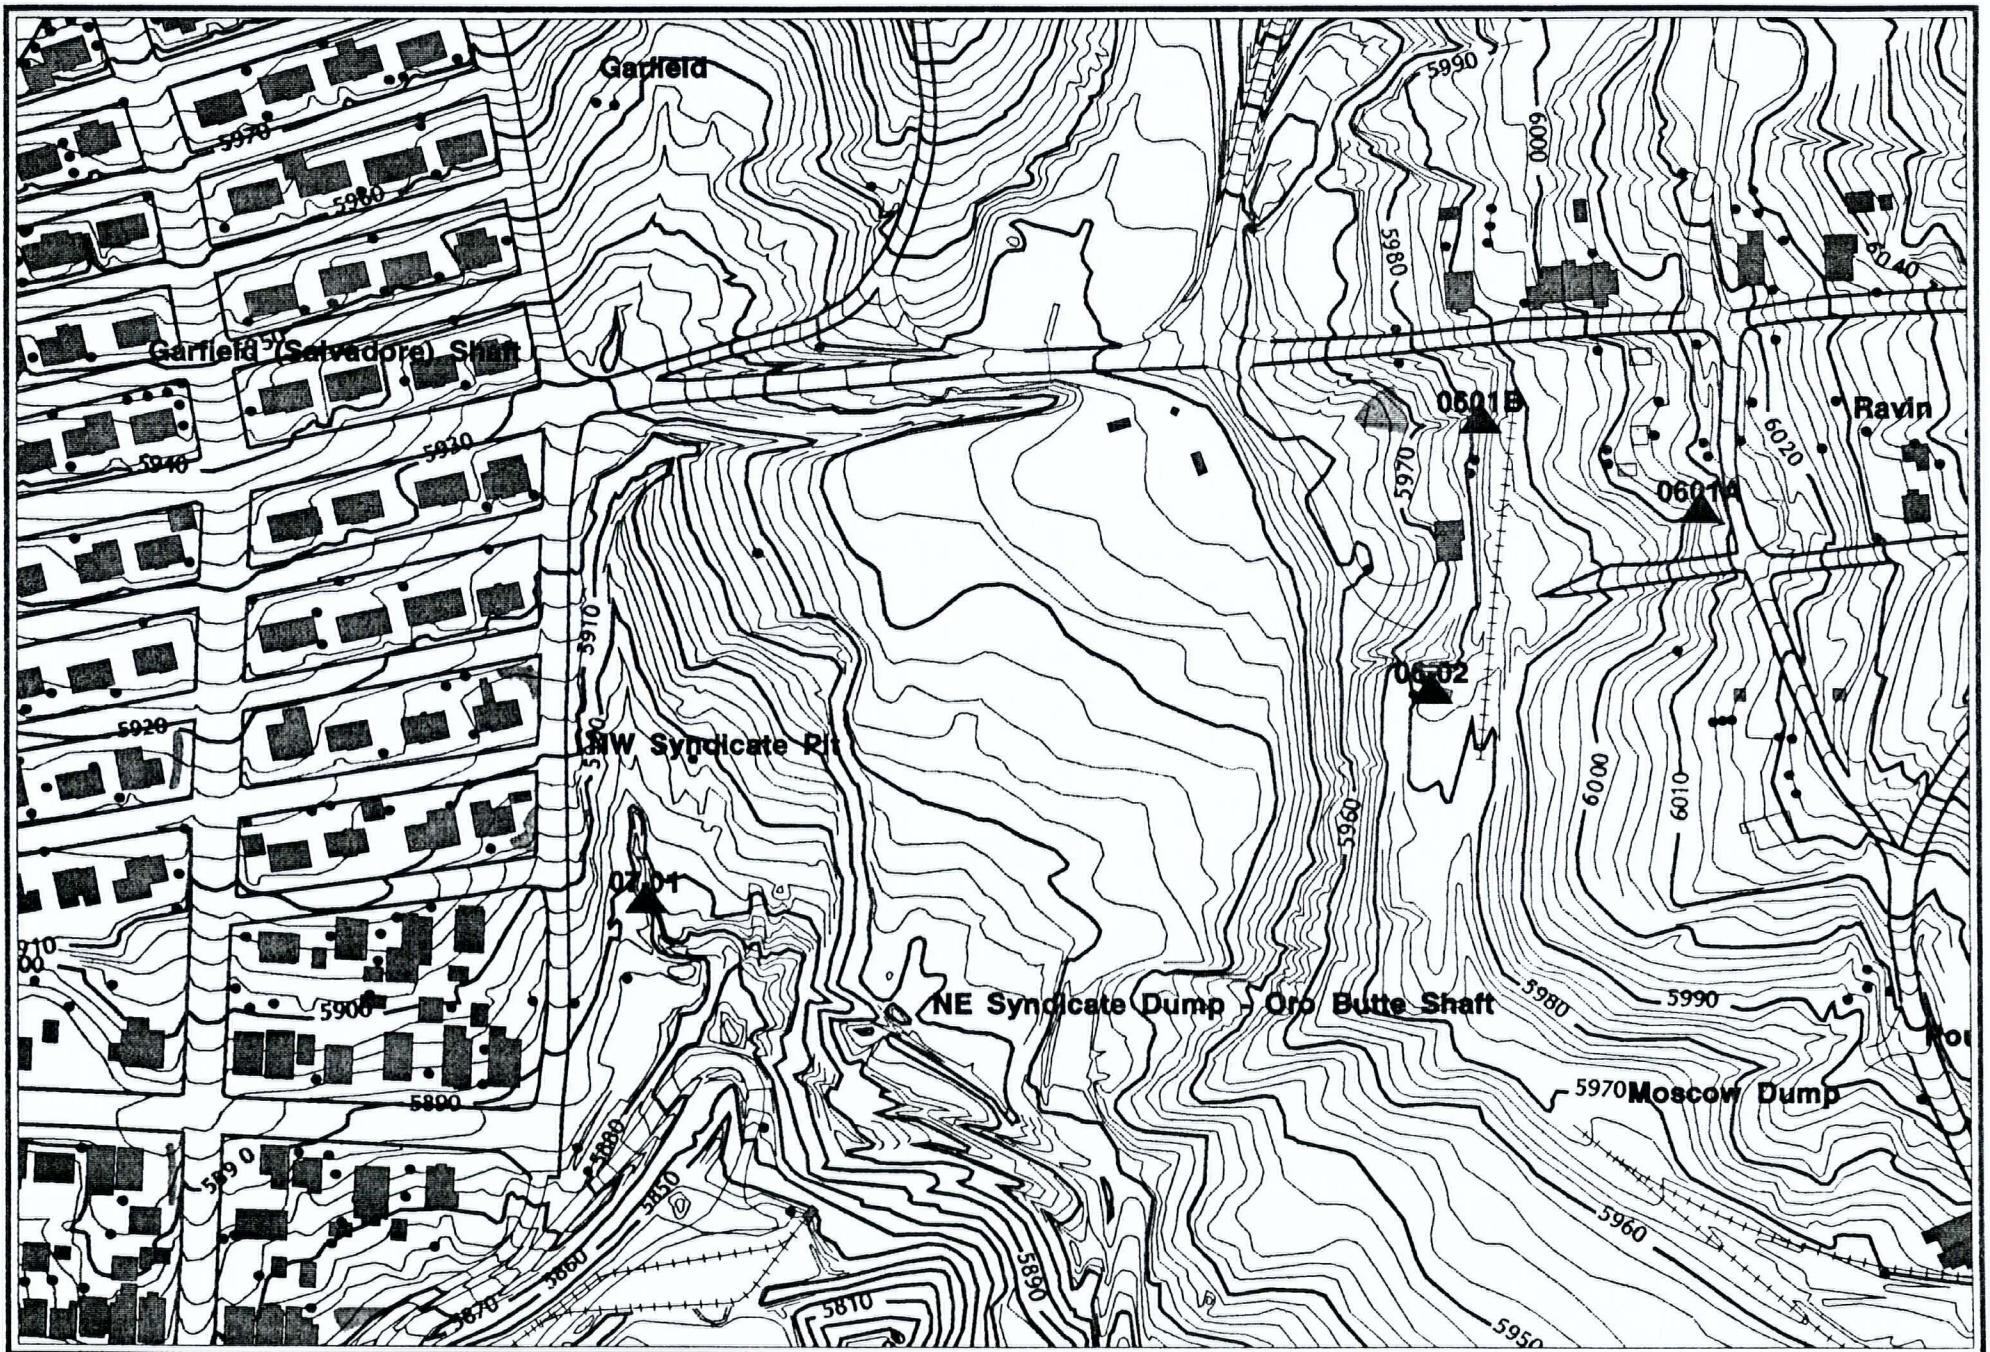
Figure 4

The sample numbers, descriptions, and analytical results are shown in Table 1. Figures 1 through 12 show the center composite sample locations of the sampled areas. Five aliquots were collected and composited for each sample that was analyzed.

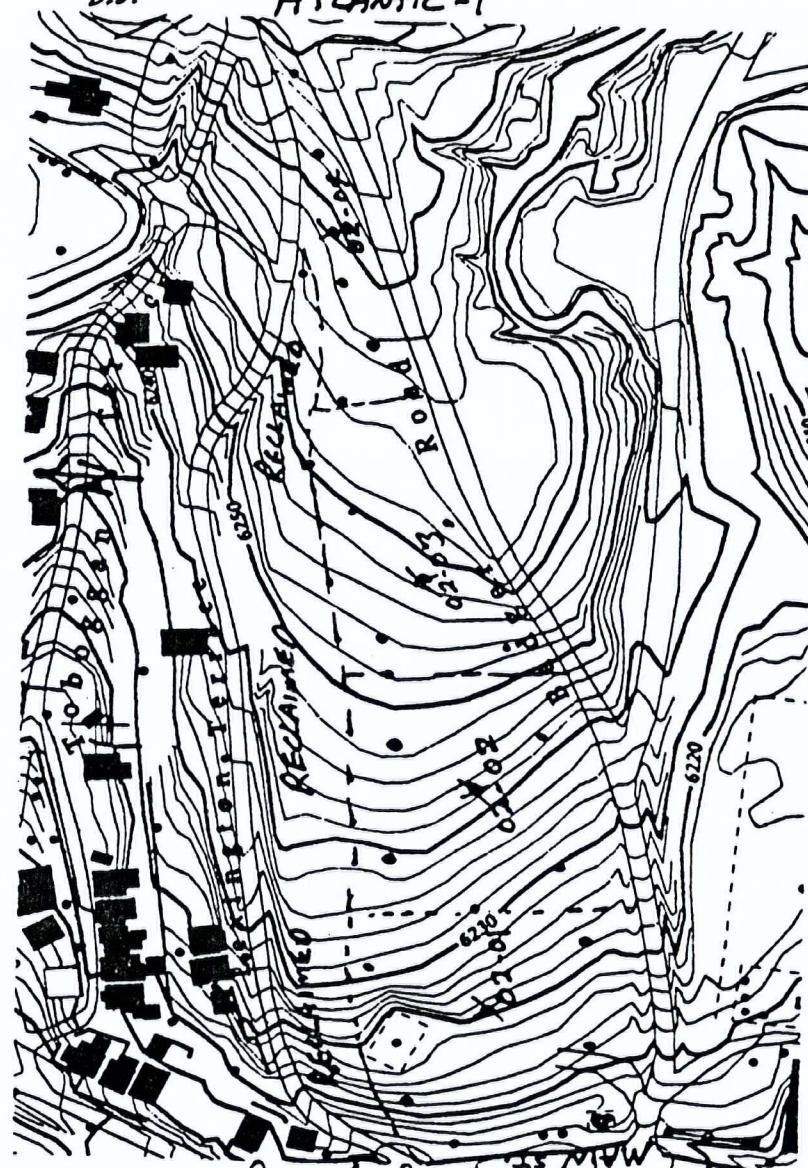
ATLANTIC-1

1440 - ARRIVE AT ATLANTIC DUMP. SET UP
FOR SAMPLING.

1500 - COLLECTED SAMPLE 038-WA-02-01.

PICTURE 1-1 TOWARD NORTH SHOWS CENTER
COMPOSITE LOCATIONS. PICTURES 1-2 & 1-3
TOWARD SOUTH - SOUTHWEST SHOW ALL
COMPOSITE LOCATIONS. (BLUE FLAGS)

1540 COLLECTED SAMPLE 038-WA-02-02.

PICTURE 17th-4 TOWARD SOUTH SHOWS
CENTER COMPOSITE LOCATIONS. PICTURES
17th-5 & 17th-6 TOWARD WEST SHOW COMPOSITE
LOCATIONS. EPA TAG # 8-79004.
SEE MAP PAGE 5

1605 COLLECTED SAMPLE 038-WA-02-03.

PICTURE 17th-7 TOWARD NORTH SHOWS
CENTER COMPOSITE SAMPLE LOCATION.
PICTURES 17th-8 17th-9, 17th-10 TOWARD NORTH
SHOW COMPOSITE LOCATIONS. EPA TAG
8-79005. SEE MAP ON PAGE 5

1630 COLLECTED SAMPLE 038-WA-02-04.
PICTURE 17th-11 TOWARD WEST SHOWS
CENTER COMPOSITE LOCATION.

The sampling results from the Atlantic-1 confirmed that two out of the four sections have lead concentrations greater than 2,300 mg/kg and should be reclaimed as discussed in the Source Area Work Plan. The third sample had a lead concentration of 2,080 mg/kg; its' potential bias was discussed above. The fourth sample collected at the east end of the Atlantic-1 had a lead concentration of 523 mg/kg, however there was visible waste material present in this area.

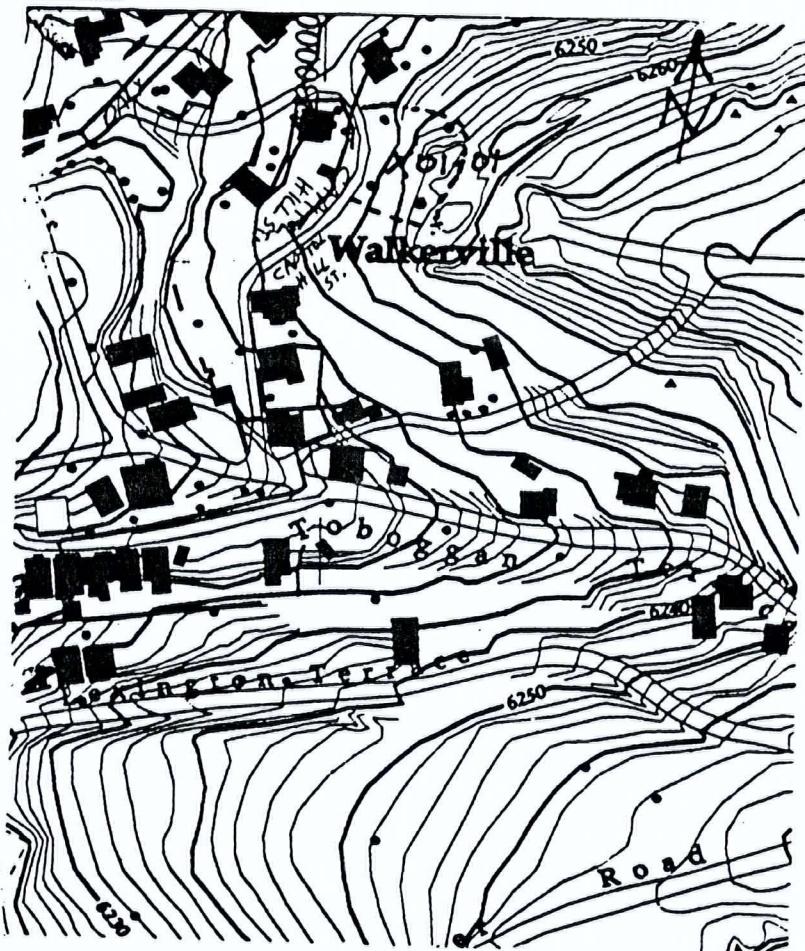
O.S. CAPITOL HILL DUMP

- 11-10-94 D. STORAND
0645 RETURN TO BUTTE. CUSTODY SEALS
WERE STILL FASTENED TO COOLER LID.
0800 MET WITH SARA WEINSTOCK & DAVE
KIRKPATRICK ABOUT ACCESS AGREEMENTS.
0850 ARRIVE AT CAPITOL HILL DUMP.
0920 COLLECTED SAMPLE 038-WA-01-01.
COMPOSITE 0-1" SAMPLE OF DUMP MATERIAL.
PICTURES 12-13 & 12-14 TOWARDS NORTH
SHOW THE 5 COMPOSITE LOCATIONS.
PICTURE 12-15 TOWARDS WEST SHOWS
CENTER COMPOSITE SAMPLE. SEE
MAP ON PAGE 7. EPA TAG # 8-79001

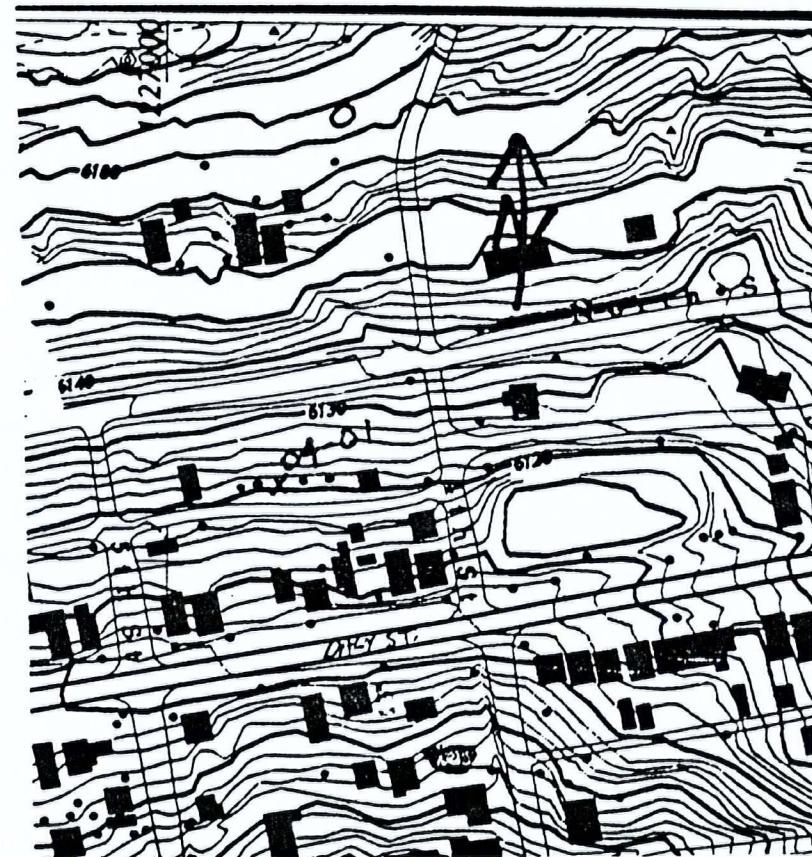
DALY AND NORTH STREET

COLLECTED 0-1" COMPOSITE SAMPLE
038-WA-04-01. BETWEEN DALY
& NORTH ST. PICTURE 1-16 TOWARDS
NE SHOWS COMPOSITE LOCATIONS. PICTURE
1-17 TOWARDS WEST SHOWS CENTER
COMPOSITE LOCATION. SEE MAP ON
PAGE 7. EPA TAG # 8-79009

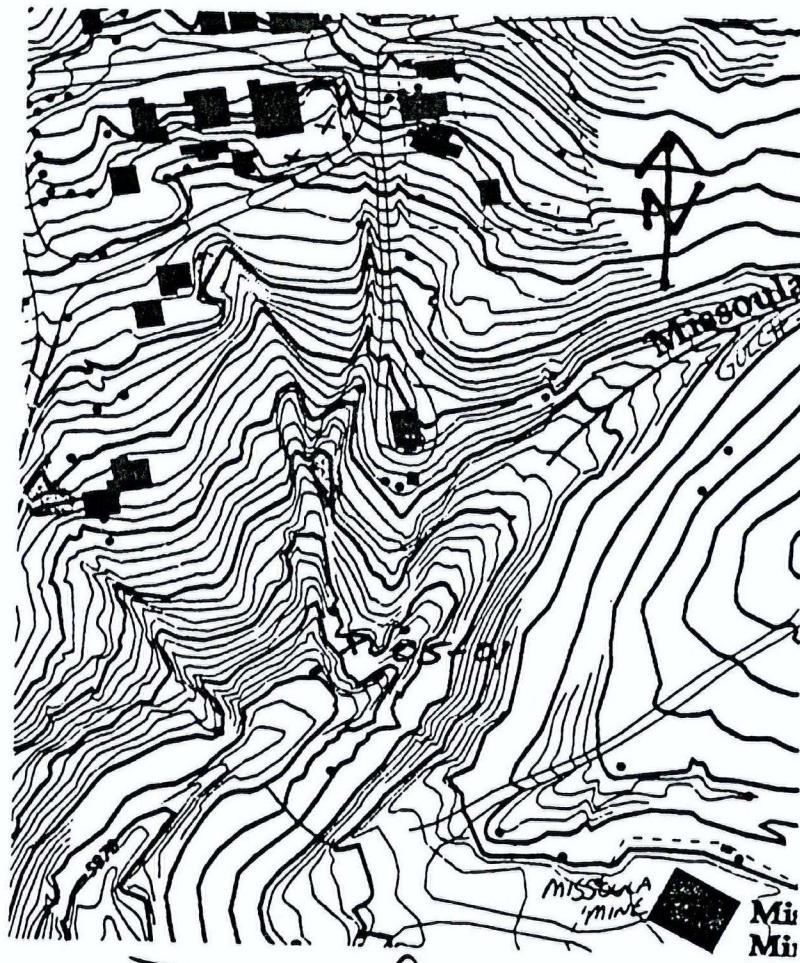
WAPPELLO DUMP

COLLECTED 0-1" COMPOSITE SAMPLE
038-WA-05-01. WAPPELLO DUMP.

PICTURE 1-18 TOWARDS NORTH SHOWS
COMPOSITE LOCATIONS. PICTURE 1-19
TOWARDS NORTH SHOWS CLOSE-UP OF
CENTER COMPOSITE LOCATION. SEE MAP
ON PAGE A. EPA TAG # 8-79010

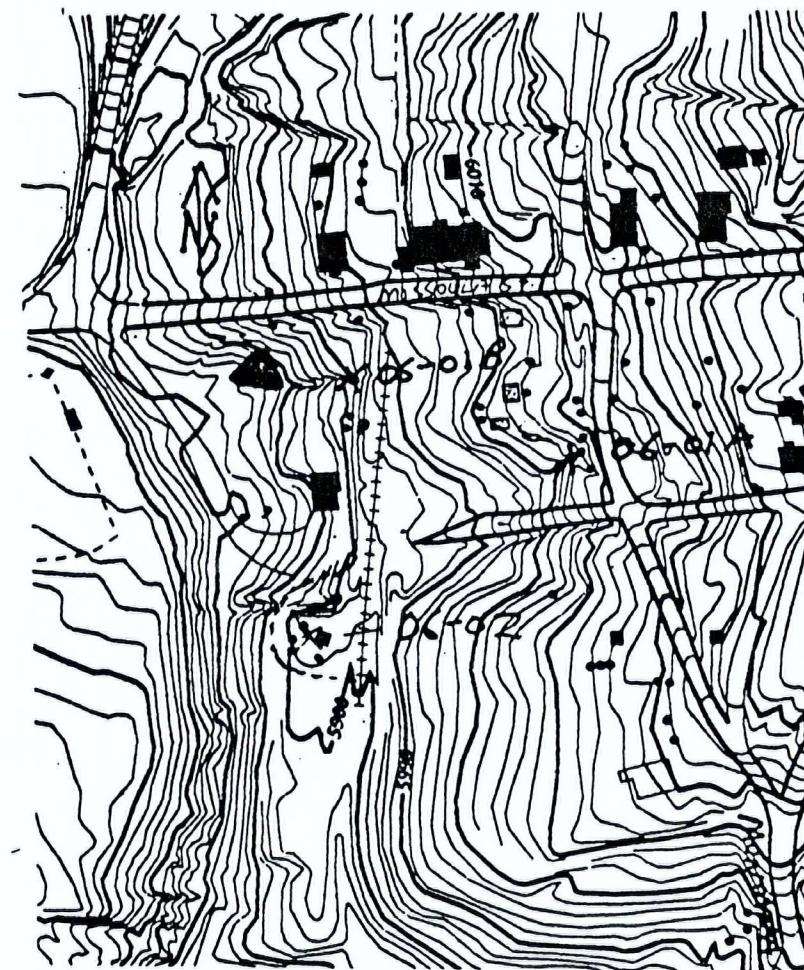
11- 4 SOUTH OF MISSOURI STREET

COLLECTED 0-1" COMPOSITE SAMPLE # 038-WA-06-01. 3 SUB SAMPLES TAKEN ON EAST END OF VACANT FIELD. 2 SUBSAMPLES TAKEN FROM RAILROAD FILL MATERIAL FROM WEST END OF LOT. PICTURE 1-20 TOWARDS WEST SHOWS 3 SUB SAMPLE LOCATIONS. PICTURE 1-21 TOWARD EAST SHOWS CLOSE-UP OF COMPOSITE LOCATION. PICTURE 1-22 TOWARD SOUTH SHOWS TWO COMPOSITE LOCATIONS AT WEST END OF LOT. SEE MAP ON PAGE 13. EPA TAG # 8-79012 COLLECTED 0-1" COMPOSITE # 038-WA-06-02. PICTURES 1-23 & 1-24 TOWARDS ~~NW~~^{NE} EAST SHOW COMPOSITE LOCATIONS. PICTURE 1-25 TOWARDS ~~NE~~^{SE} EAST SHOWS 2 COMPOSITE LOCATIONS. SEE MAP ON PAGE 13.
EPA TAG # 8-79011

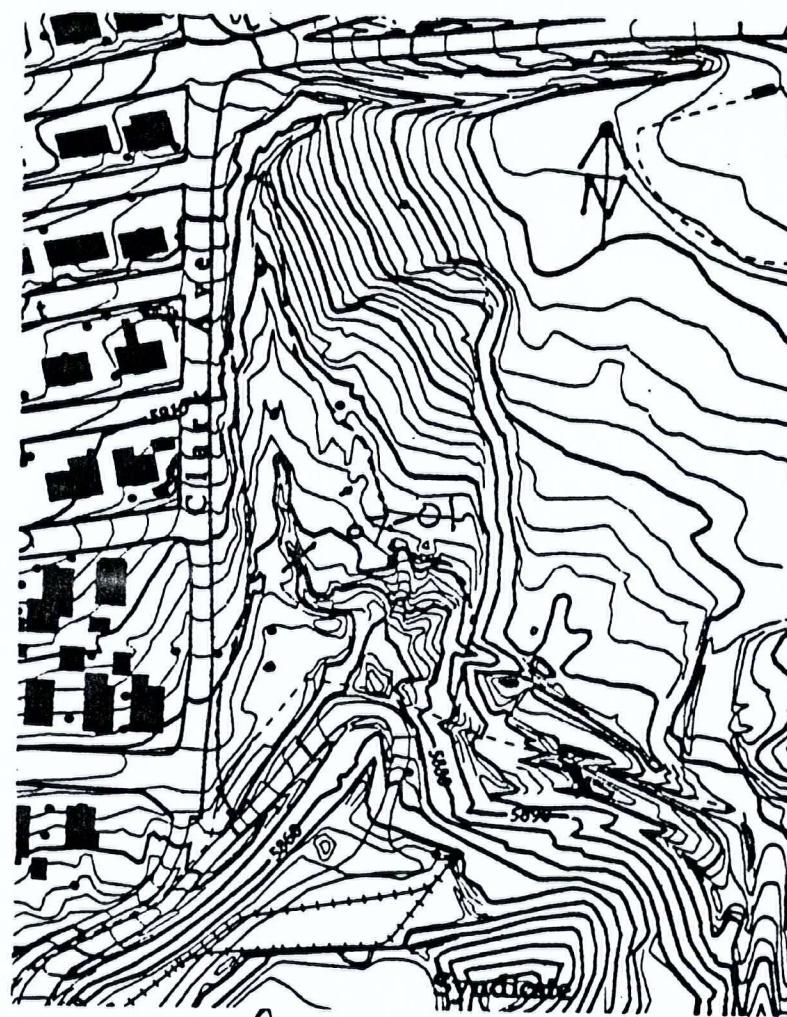
MISSOURA GULCH DITCH
NORTH OF SYNDICATE PIT

1310 COLLECTED 0-1" COMPOSITE SAMPLE
038-WA-07-01, 3¹⁰⁰/₂ SUBSAMPLES
TAKEN FROM DITCH. 2 TAKEN
ON EAST & WEST SIDES OF DITCH.
PICTURE 1-26 TOWARDS NORTH
SHOWS 2 SUBSAMPLE LOCATIONS. PICTURE
1-27 TOWARD SOUTH SHOWS CENTER
COMPOSITE LOCATION IN DITCH. PICTURES
2-1 & 2-2 TOWARDS SE SHOWS
SOUTH END OF MISSOURA GULCH DITCH
ABOVE SYNDICATE PIT. SEE MAP
ON PAGE 15. EPA TAG #8-79013

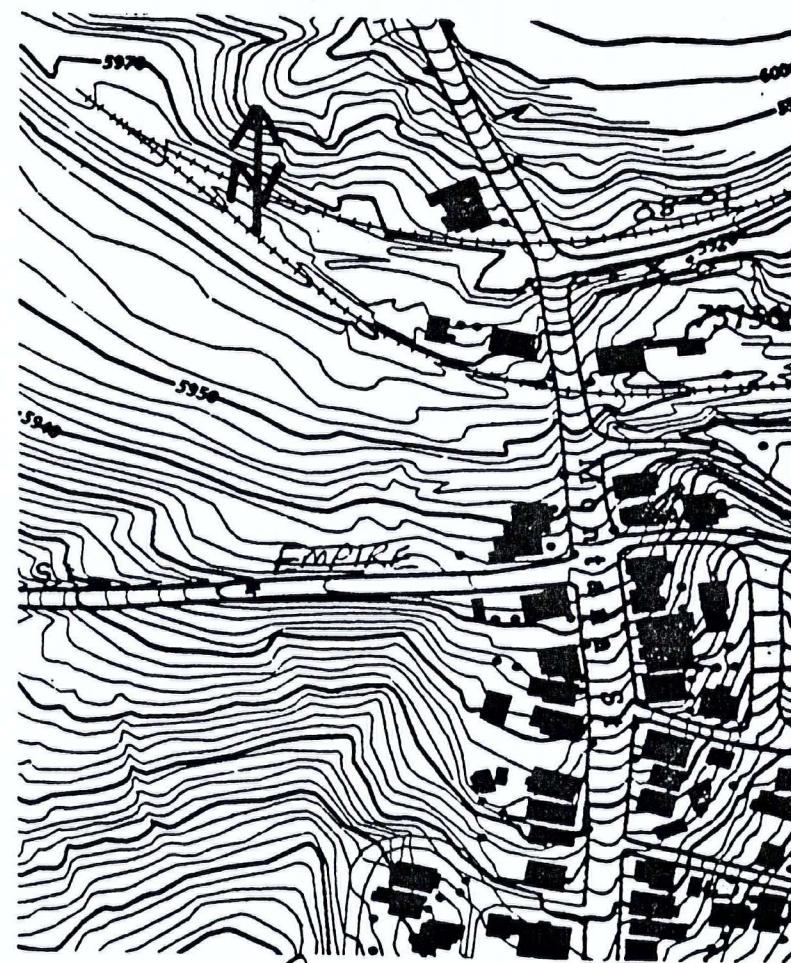
NORTH OR WEST
RUBY DUMP

COLLECTED 0-1" COMPOSITE SAMPLE
038-WA-08-01. PICTURE 2-3 OS
TOWARD EAST SHOWS COMPOSITE LOCATIONS.
SEE MAP ON PAGE 17. EPA
TAG # 8-79015.

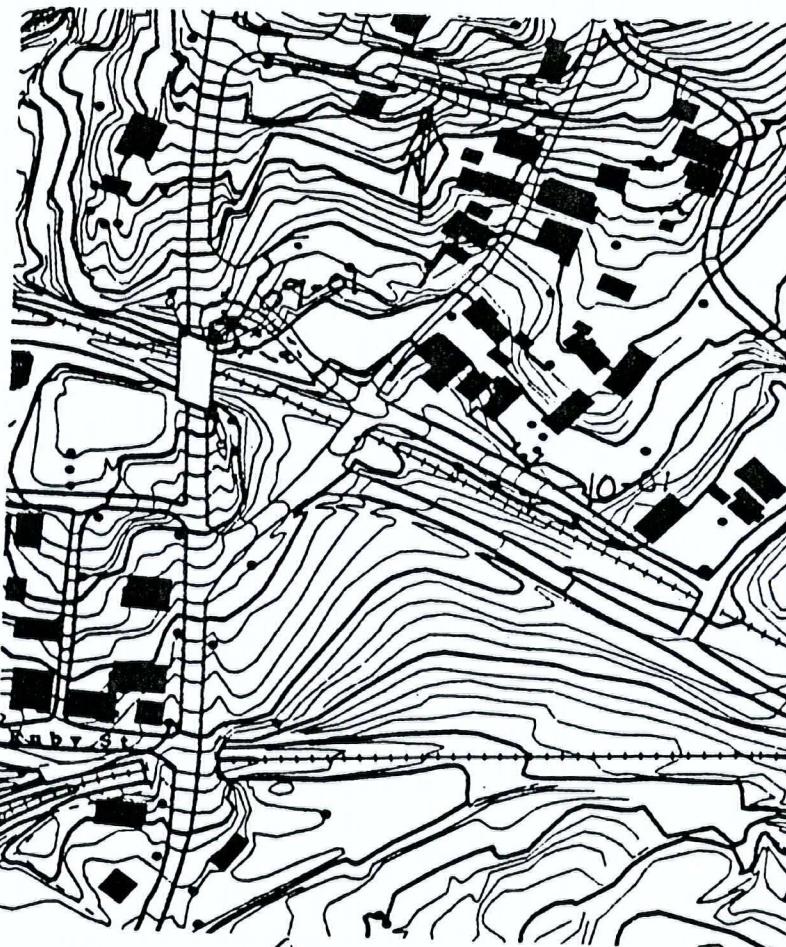
EAST OF MAIN ST.
EAST BRIDGE / SOUTH OF RAILROAD

COLLECTED 0-1" COMPOSITE SAMPLE
038-WA-07-01. WASTE MATERIAL
EAST OF MAIN ST. BRIDGE. PICTURES
2-7, 2-8, & 2-9 TOWARD EAST SHOW
COMPOSITE LOCATIONS. SEE MAP ON
PAGE 21. EPA TAG # 8-79016.
COLLECTED 0-1" COMPOSITE SAMPLE
038-WA-10-01. PICTURE 2-10
TOWARDS NORTH SHOWS CLOSE-UP
OF CENTER COMPOSITE SAMPLE.
PICTURE 2-11 TOWARDS EAST SHOWS
ALL COMPOSITE LOCATIONS. SEE
MAP ON PAGE 21. EPA TAG
8-79017.

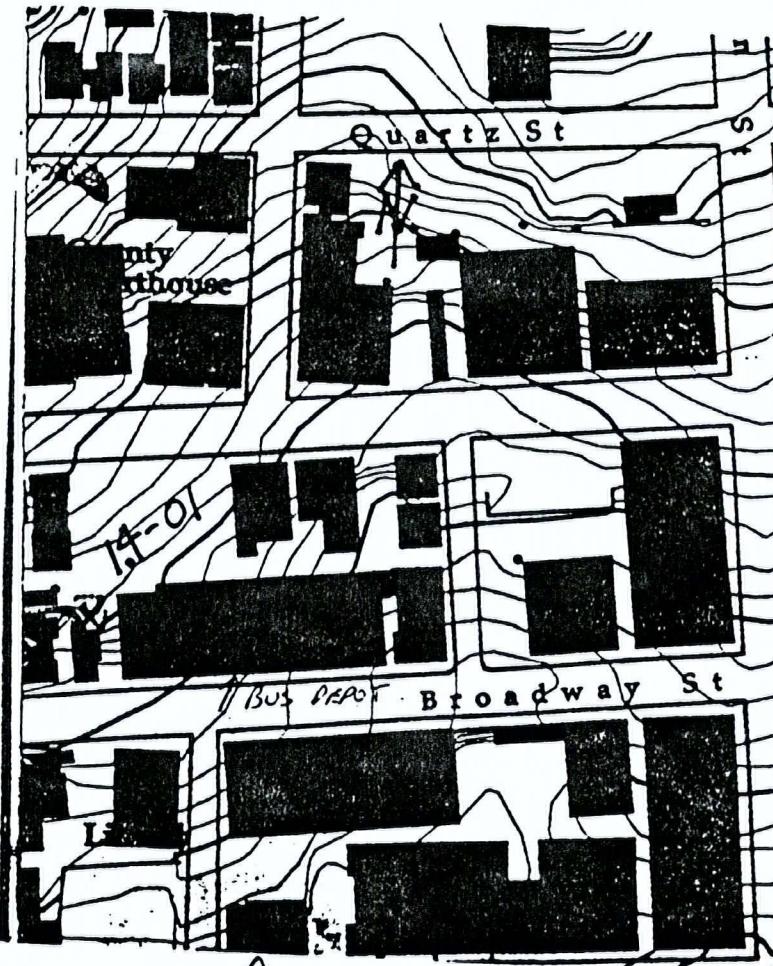
WEST OF
BUS DEPOT

- 11-11
0700 HEAD BACK TO BUTTE. CUSTODY SEALS
STILL FASTENED TO COOLER LID.
0820 ARRIVE IN BUTTE TO MEET DAVE AT
EPA OFFICE. WENT OVER FINAL ACCESS
AGREEMENTS.
0940 COLLECTED 0-1" COMPOSITE SAMPLE
038-WA-14-01. SMALL WASTE DUMP
USED AS PARKING LOT. PICTURE
2-18 TOWARDS NW SHOWS CLOSE-UP OF
CENTER COMPOSITE LOCATION. PICTURE
2-19 TOWARDS WEST SHOW COMPOSITE
LOCATIONS. SEE MAP ON PAGE 25.
EPA TAG # 8-79021

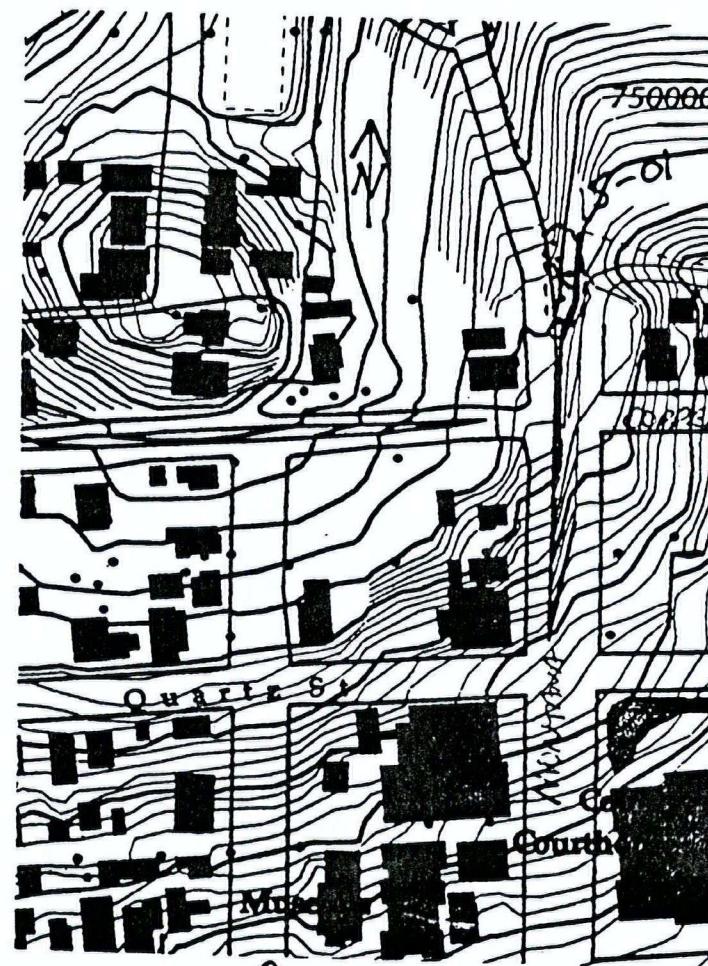
EAST BANK OF
MONTANA AVE.

COLLECTED ALFT 0-1" COMPOSITE
SAMPLE 038-WA-15-01. PICTURE
2-20 TOWARD SOUTH. 2-21 TOWARD
NORTH SHOWS COMPOSITE LOCATIONS. PICTURE
2-22 TOWARD WEST SHOWS CLOSE-UP
OF CENTER COMPOSITE. PICTURE 2-23
TOWARD SW SHOWS RETAINING WALL.
SEE MAP ON PAGE 27. EPA TAG
8-79022.

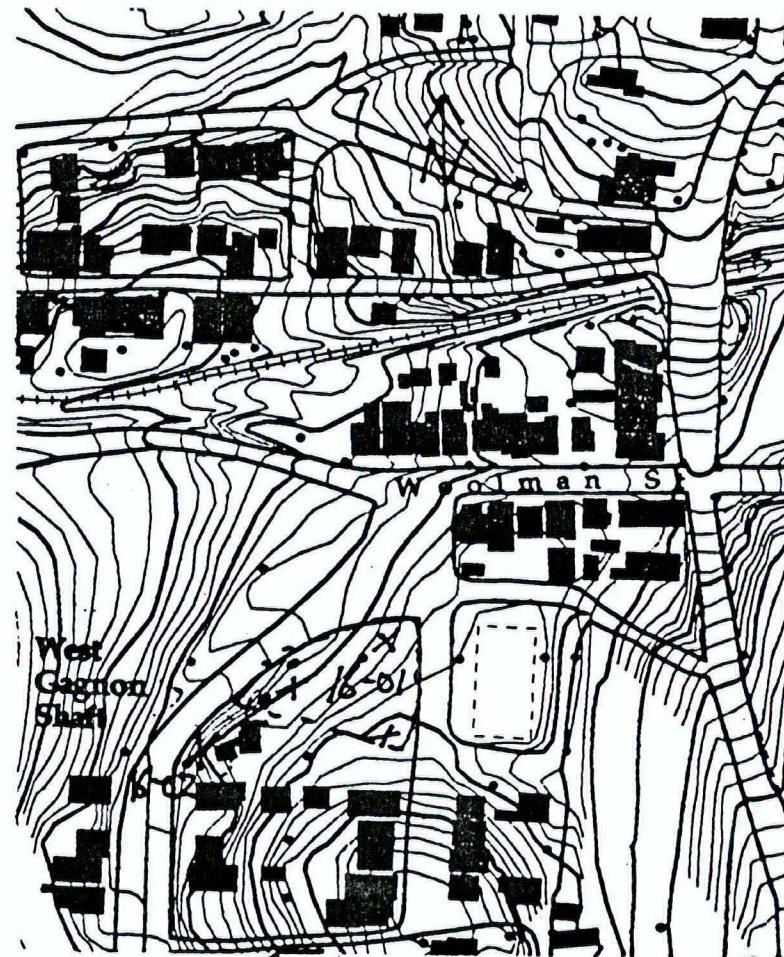
NATIONAL DUMP
WEST / SOUTHWEST

COLLECTED 0-1" COMPOSITE SAMPLE
038-WA-16-01. PICTURES 2-24 & 2-25
TOWARDS NORTH SHOWING COMPOSITE
LOCATIONS. PICTURE 2-26 TOWARDS
NORTH SHOWS CENTER COMPOSITE
CLOSE-UP. SEE MAP ON PAGE 29.
EPA TAG # 8-79023.

COLLECTED 0-1" COMPOSITE SAMPLE
038-WA-16-02. SMALL WASTE DUMP
WITH SHED ON TOP. PICTURE 2-27
TOWARDS EAST SHOWS CLOSE-UP OF
CENTER SUB-SAMPLE. PICTURES 2-28
& 2-29 TOWARDS EAST SHOWING 5
SUB-SAMPLE⁰²'S SUB-SAMPLE LOCATIONS.
SEE MAP ON PAGE 29. EPA
TAG # 8-79024

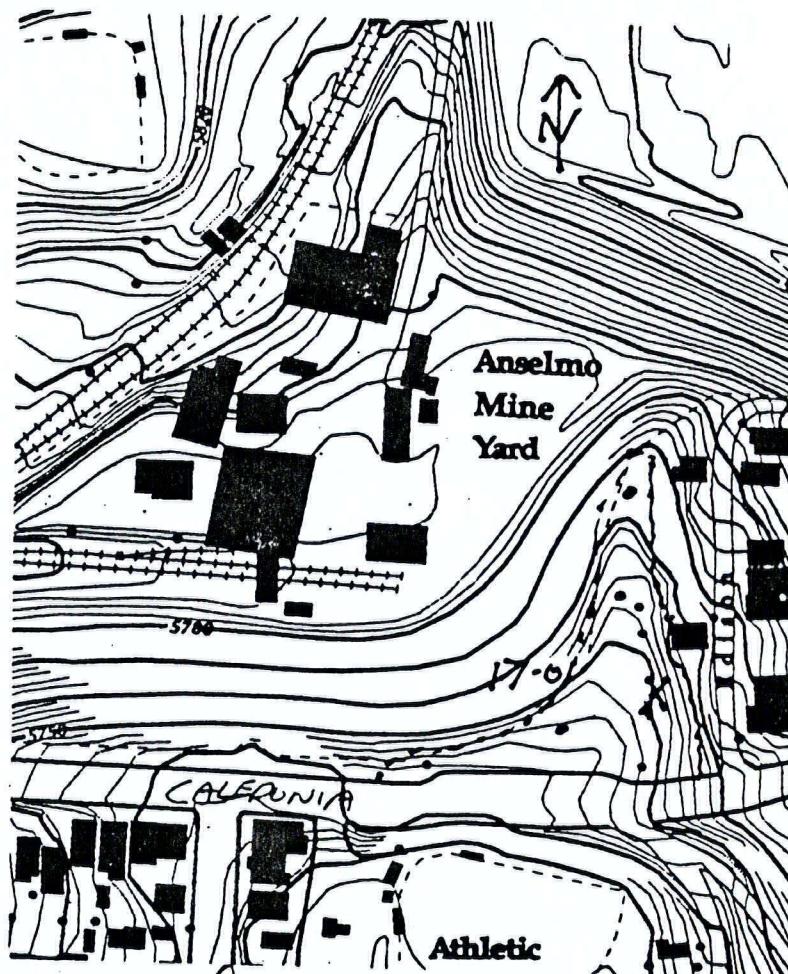
EAST OF ANSELMO
MINE YARD

COLLECTED 0-1" COMPOSITE SAMPLE
030-WA-17-01. PICTURE 2-30
TOWARDS NE SHOWING SUB-SAMPLE
LOCATIONS. PICTURES 2-31 - 2-32
TOWARDS NORTH SHOWING LOCATIONS
& CLOSE-UP OF CENTER COMPOSITE.
SEE MAP ON PAGE 31. EPA
TAG # 8-79025

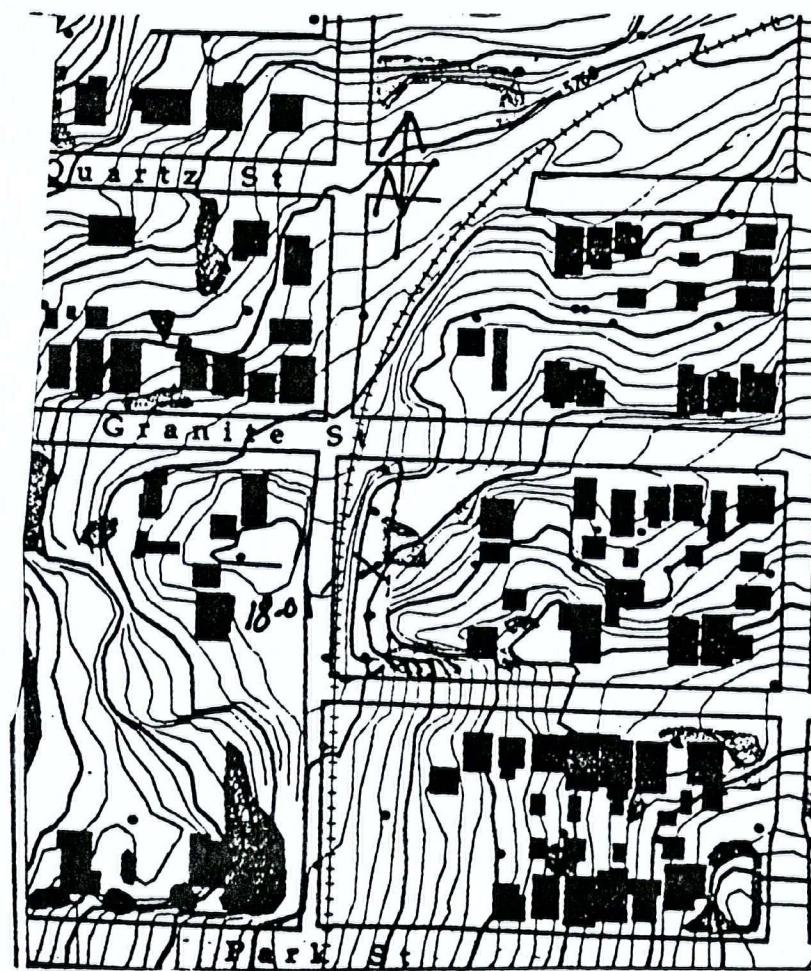
WESTERN ST.
RAILROAD GRADE

COLLECTED 0-1" COMPOSITE SAMPLE
038-WA-18-01. PICTURES 2-33 &
2-34 TOWARDS NORTH SHOWING
SUB-SAMPLE LOCATIONS & CLOSE-UP OF
CENTER COMPOSITE LOCATION,
SEE MAP ON PAGE 33. EPA
TAG # 8-77026. CHAMBERS PS.

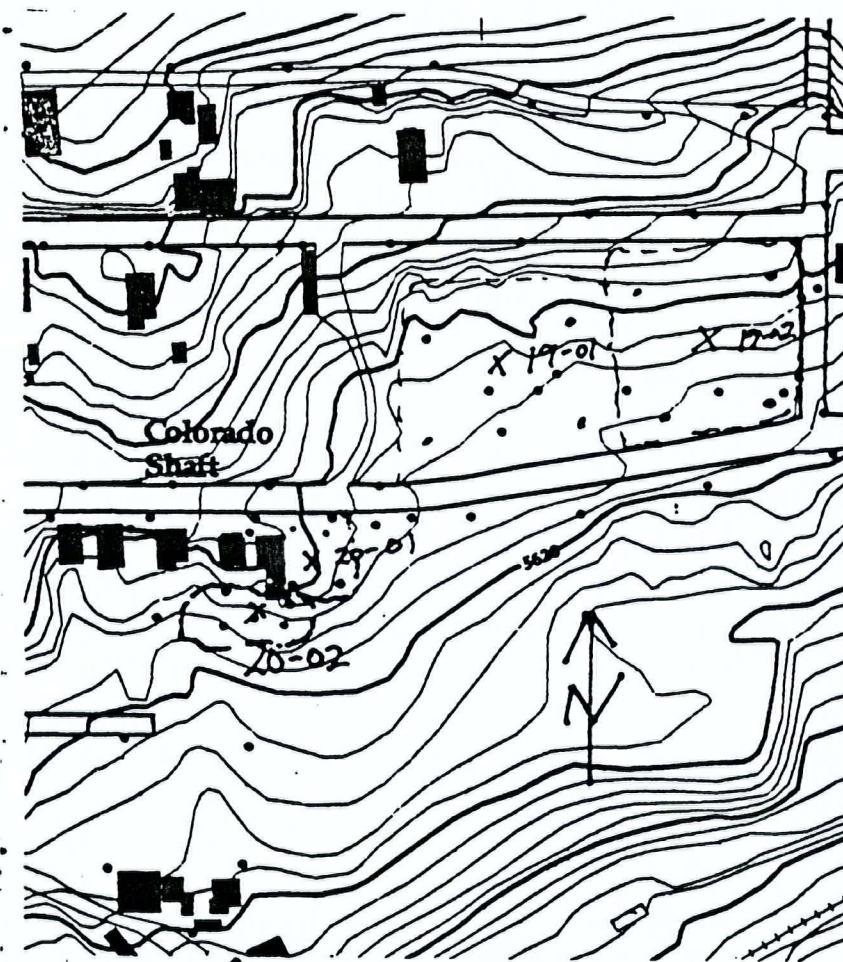
U. STROAK
 11-11-94
 SOUTH OF HOY HICKEY/
 WEST OF BUTTE/NEW ENGLAND

- 11 94 D. STROAK
 1330 & KIRKPATRICK SUNNY COOL
 COLLECTED 0-1" COMPOSITE SAMPLE
 038-WA-19-01. PICTURE 2-35
 TOWARDS WEST SHOWING CENTER
 SUB-SAMPLE. PICTURES 2-36 & 37
 LOOKING SW AT COMPOSITE LOCATIONS.
 SEE MAP ON PAGE 35. EPA
 TAG # 8-79027

- 1350 COLLECTED 0-1" COMPOSITE SAMPLE
 038-WA-19-02. PICTURES 3-1,
 3-2, & 3-3 TOWARDS NORTH SHOWING
 COMPOSITE LOCATIONS. SEE MAP ON
 PAGE 35. EPA TAG # 8-79028

- 1400 COLLECTED 0-1" COMPOSITE SAMPLE 038-WA-
 20-01. PICTURES 3-4 & 3-5 TOWARDS NORTH
 SHOW LOCATIONS. SEE MAP ON PAGE 35.
 EPA TAG # ~~8-79028~~^{OS} 8-79029

- 1410 COLLECTED 0-1" COMPOSITE SAMPLE
 038-WA-20-02. PICTURES 3-6 & 3-7
 TOWARDS NORTH SHOW COMPOSITE LOCATIONS.
 PICTURE 3-8 TOWARDS EAST SHOWS CLOSE-
 UP OF CENTER COMPOSITE LOCATION. SEE
 MAP ON PAGE 35. EPA # 8-79029^{OS} 79030

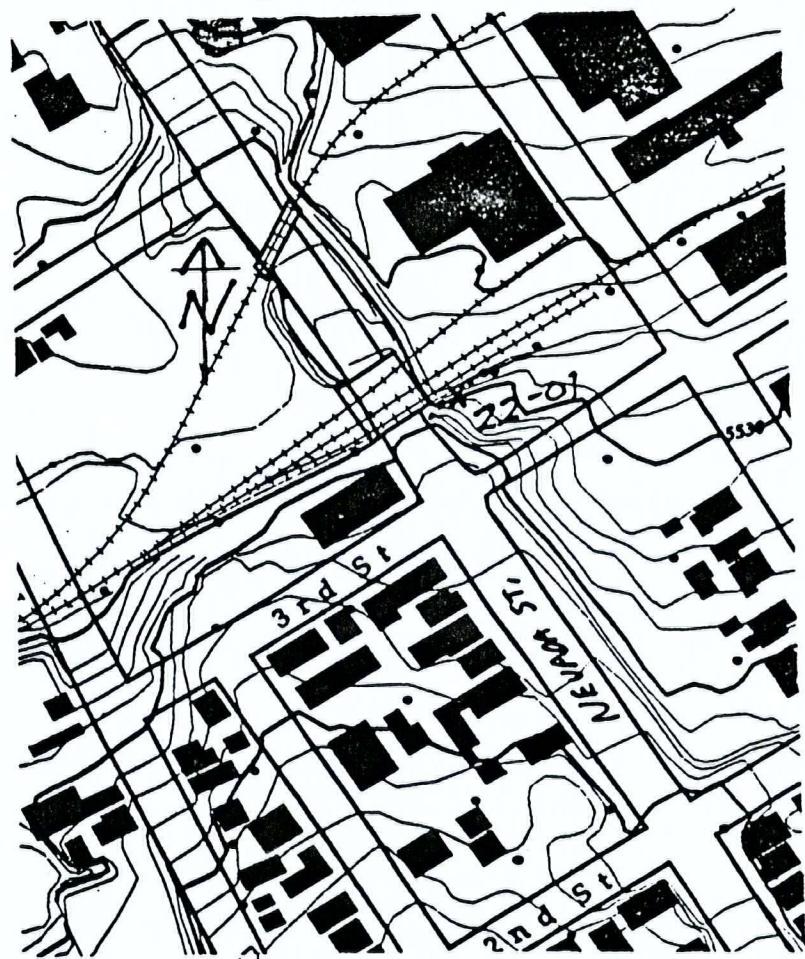
NEVADA AND THIRD ST.
BRIDGE

- 1455 COLLECTED RINSEATE BLANK
SAMPLE # 038-WA-21-01.
POURED DISTILLED WATER OVER TROWEL
& BOWL. EPA TAG # 8-79032.
1520 COLLECTED 0-1" COMPOSITE SAMPLE
038-WA-22-01. PICTURE 3-9
NORTH LOOKING AT CENTER COMPOSITE.
PICTURE 3-10 TOWARDS NE. PICTURE
3-11 NW SHOWING COMPOSITE
LOCATIONS. SEE MAP ON PAGE 37
EPA TAG # 8-79033

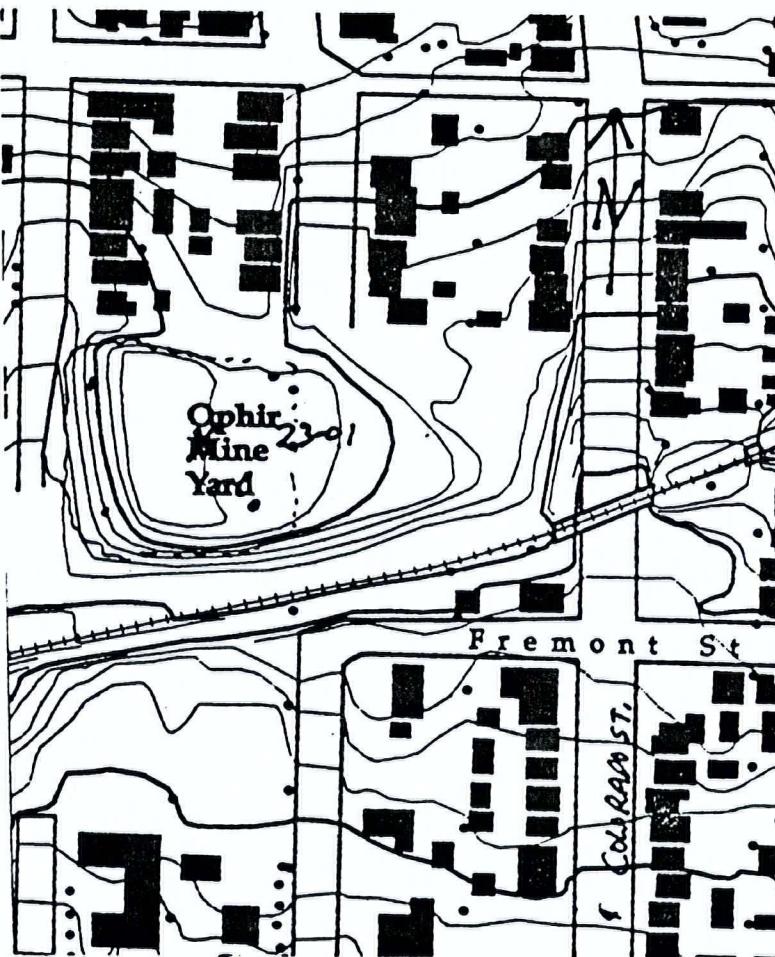
OPHIR Dump

The lead concentration found in the coversoil at the Ophir Dump met the current coversoil requirements; however, copper concentrations were high and may present phytotoxic problems. The sample of coversoil contains 2,120 mg/kg of copper which is higher than the potentially phytotoxic copper concentration of 100 mg/kg. The poor vegetation growth on the Ophir may be directly attributable to soil copper concentrations.

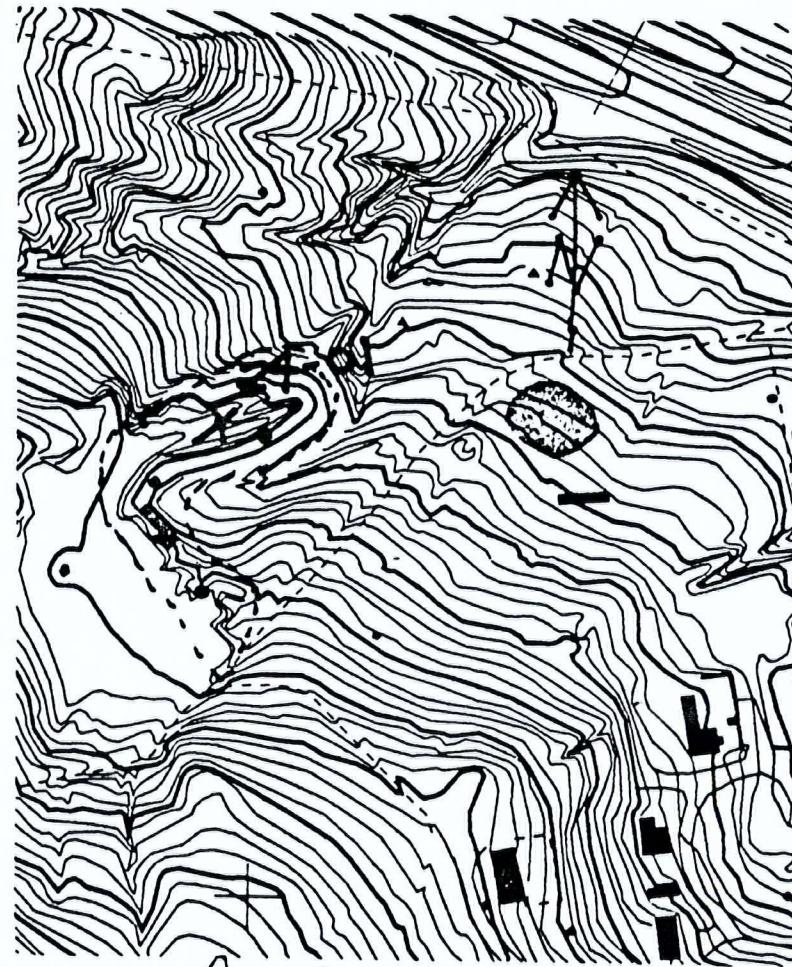
UNAMED Dump
(#198)

1340 COLLECTED 0-1" COMPOSITE SAMPLE
038-WA-24-01. PICTURE 3-16
TOWARD SE. PICTURE 3-17 SE SHOWING
CLOSE-UP OF CENTER COMPOSITE SAMPLE.
PICTURES 3-18, 3-19, 3-20 TOWARD
NORTH - NW SHOWING COMPOSITE
LOCATIONS. SEE MAP ON PAGE
41. EPA TAG NO. 8-79035

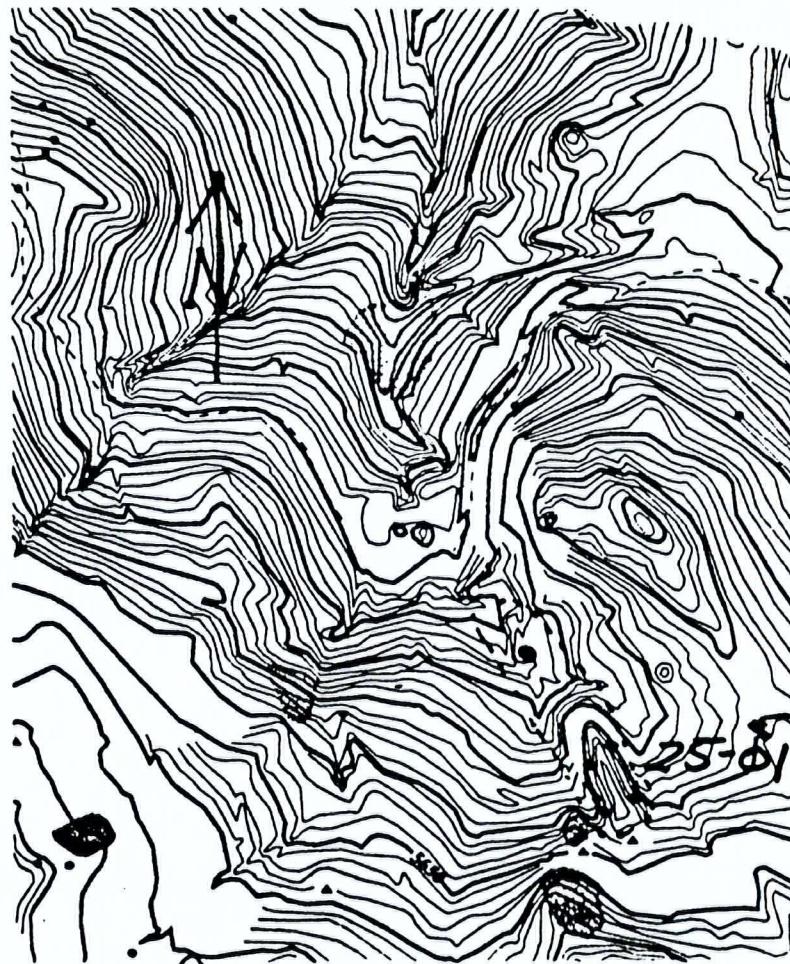
DUMP SOUTH OF
UNAMED DUMP #148

COLLECTED 0-1" COMPOSITE
SAMPLE 038-WA-25-01. PICTURE
3-21 TOWARDS NW. PICTURE 3-22
TOWARDS EAST. PICTURE 3-23 SHOWS
CLOSE-UP OF AMP MATERIAL TOWARDS
SOUTH. SEE MAP ON PAGE 43.
EPA TAG # 7008 8-79036.

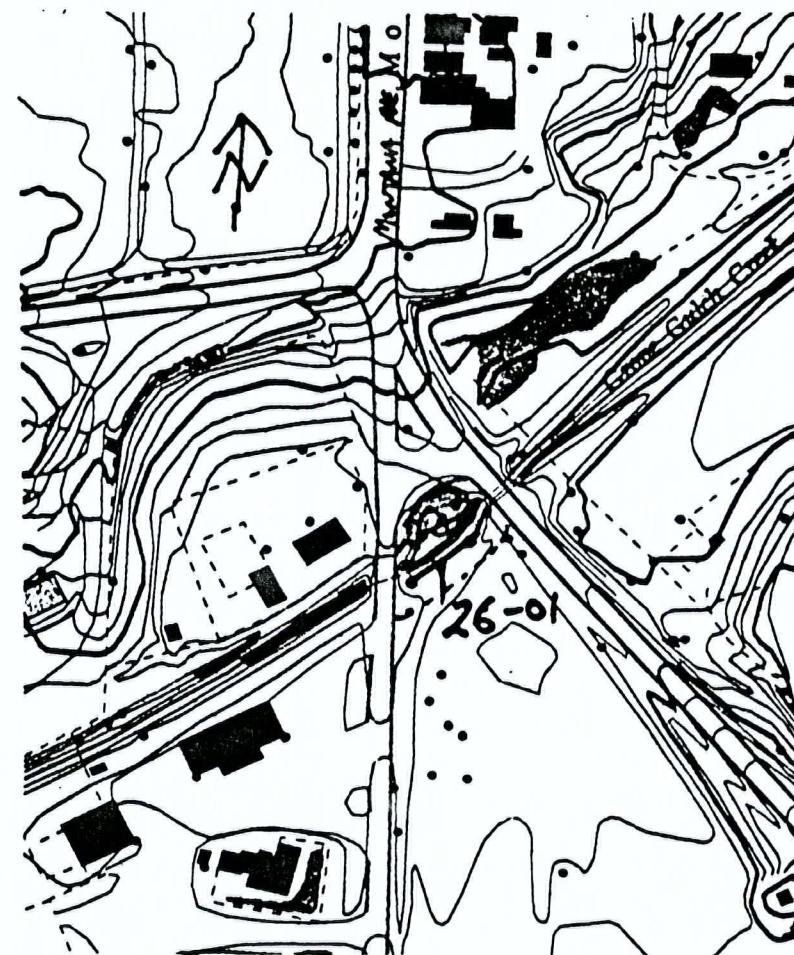
GROVE GULCH CREEK
(HAFFER PROPERTY)

- 1510 COLLECTED 0-1" COMPOSITE SAMPLE
038-WA-26-01. PICTURE 3-24
TOWARDS SE. PICTURE 3-25 TOWARDS
NW. SAMPLES TAKEN ON BOTH
SIDES OF GROVE GULCH CREEK.
SEE MAP ON PAGE 95. EPA
TAG # 8-77037
- 1600 ADDED ICE TO COOLER. PREPARED
SAMPLES FOR SHIPMENT TO PAGE
LABORATORIES. PLACED CUSTODY
SEALS ON COOLER. FEDERAL EXPRESS
SHIPMENT # 8850469375.
- 1750 SHIPPED SAMPLES FROM HELENA
FEDERAL EXPRESS OFFICE. CHAN OF
CUSTODY #'S 187900-187902, 187904, 153,995
& 36582.
